The Plasterers Inspection Process (part 2 in a 3 part series)

In the last edition (OTS 18 which is available at www.awci.org.au) we discussed what to look for when inspecting the painted decorated surface of plasterboard. In this edition we look at the plasterboard in accordance with AS/NZS 2589 with the default level 4 finish viewed at a distance of 1.5 to 1.8m.

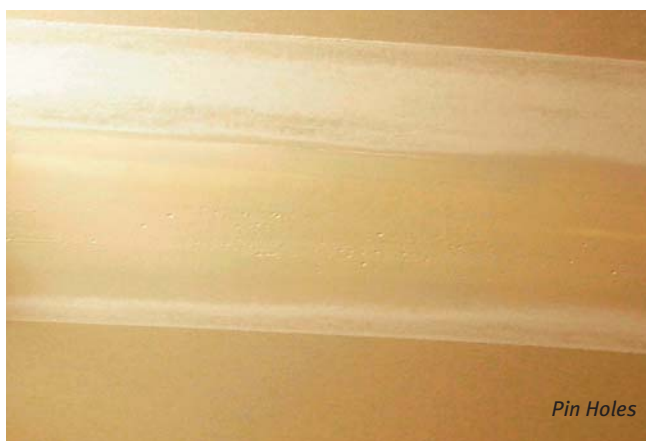
Pin holes – Usually meaning that you have applied wet on wet in too much of a hurry. Plaster compounds need sufficient time to dry, otherwise the moisture (humidity blisters) comes to the surface and causes defects which may not be noticed until the job has been painted as they are not visible when filled with sanding dust. Pin Holes are also known as pock marks.

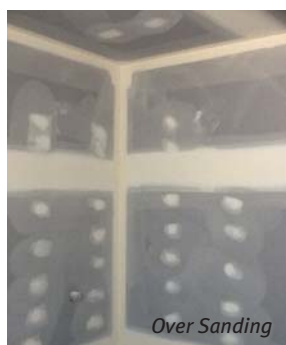
Over Sanding

Over sanding and scratches – Generally are caused by using too coarse a grit and going outside the set compound areas. With softer compounds available now, it is wise to speak with your supplier and consider using finer grits in your abrasive selection.
